## Quick-Out carabiner safety notice - 7. December 2016

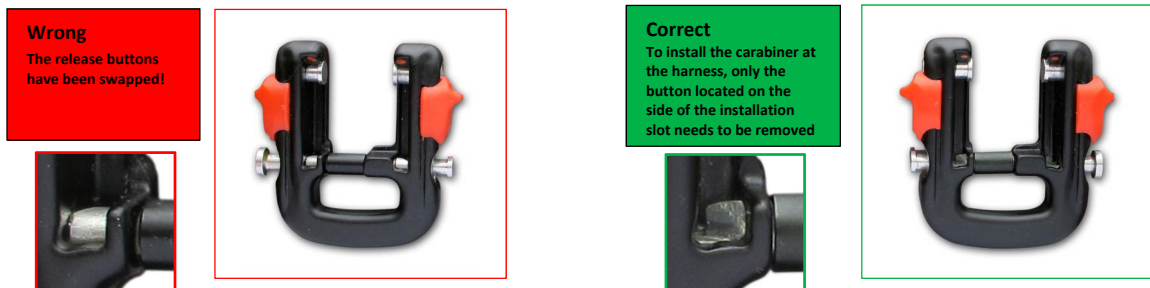
on 15 November 2016, the faulty assembly of a Quick-Out carabiner lead to its accidental opening. The pilot had dismantled both of the Quick-Out's release buttons and later re-installed them in swapped positions.

**The image on the left shows a Quick-Out carabiner with improperly installed release buttons.**

Swapping the release buttons is dangerous to life. In our instruction manual, we hence point out that the release button located on the opposite side of the installation slot must not be dismantled when attaching the carabiner to the harness. It may only be removed for cleaning purposes after the carabiner had been exposed to salt water. However, to prevent swapping the release buttons, only one button at a time may be dismantled!
